HAZARDOUS WASTE SITE ASSESSMENT REPORT

Baltimore Steel Drum
~~BUCK-STEEL-DRUM~~

910 S. KRESSON STREET, BALTIMORE, MD

DATE: FEBRUARY 15, 1982

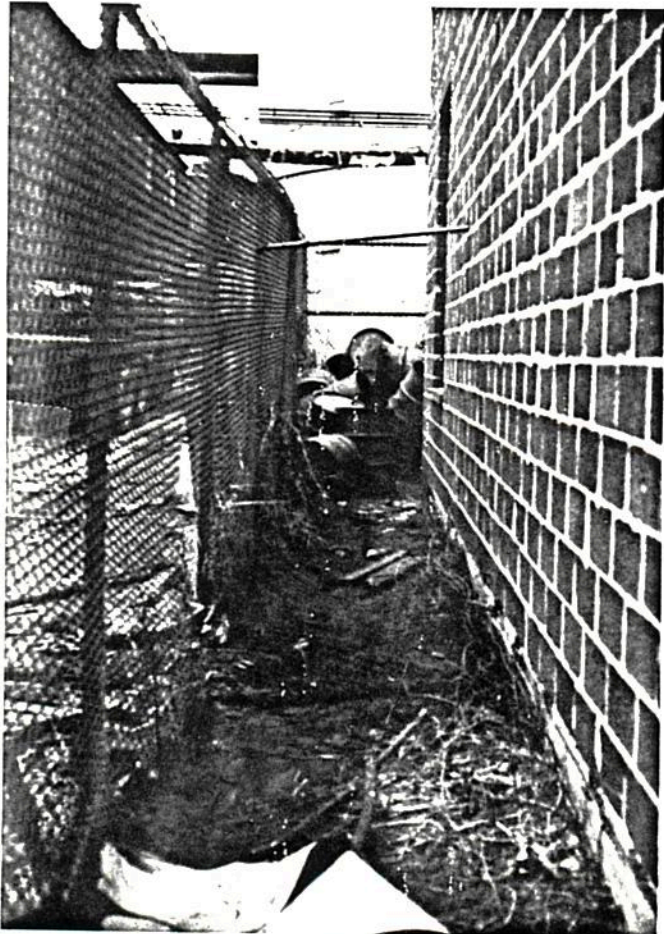
6. Facing southwest. Drums stacked along west fence. Neighboring building in background. Drums empty/full and rusted.
- 7 - 8. Facing north between west fence and Building #1. Note hole in fence. Drums fallen from stack behind Building #1.

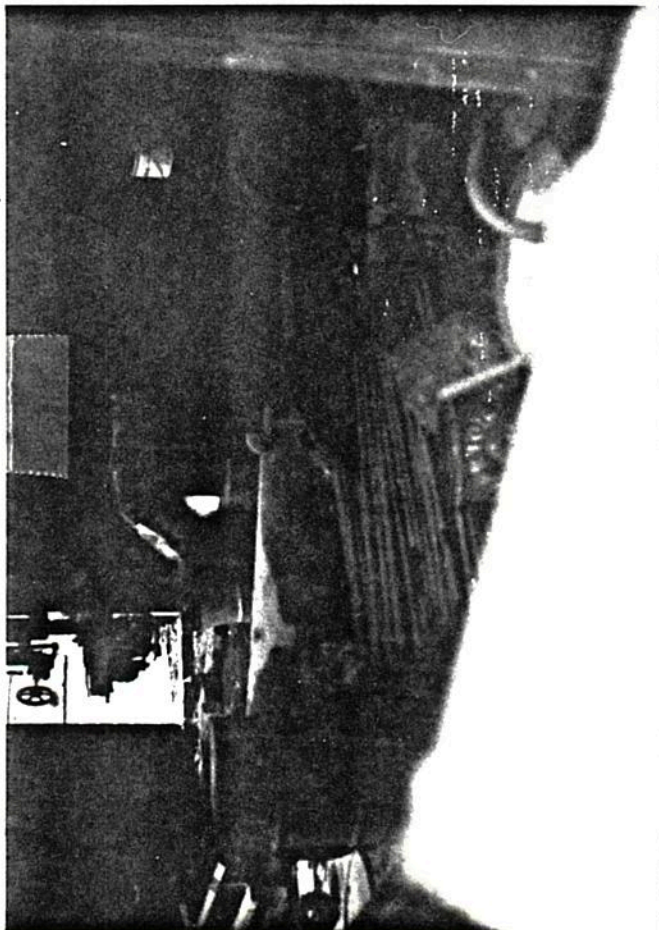
14. Facing south. Building #2 on left. Note incinerator on left (white structure). Note black, charred appearance. Material in foreground has been spilled from drums. Note fence in background has been broken.
